Memorandum

From: Steve Willis
To: Wayne Miller
Date: October 25, 2018
Subject: Site visit to inspect the landfill cap at Former Williams Air Force Base Site LF004, September 25, 2018.

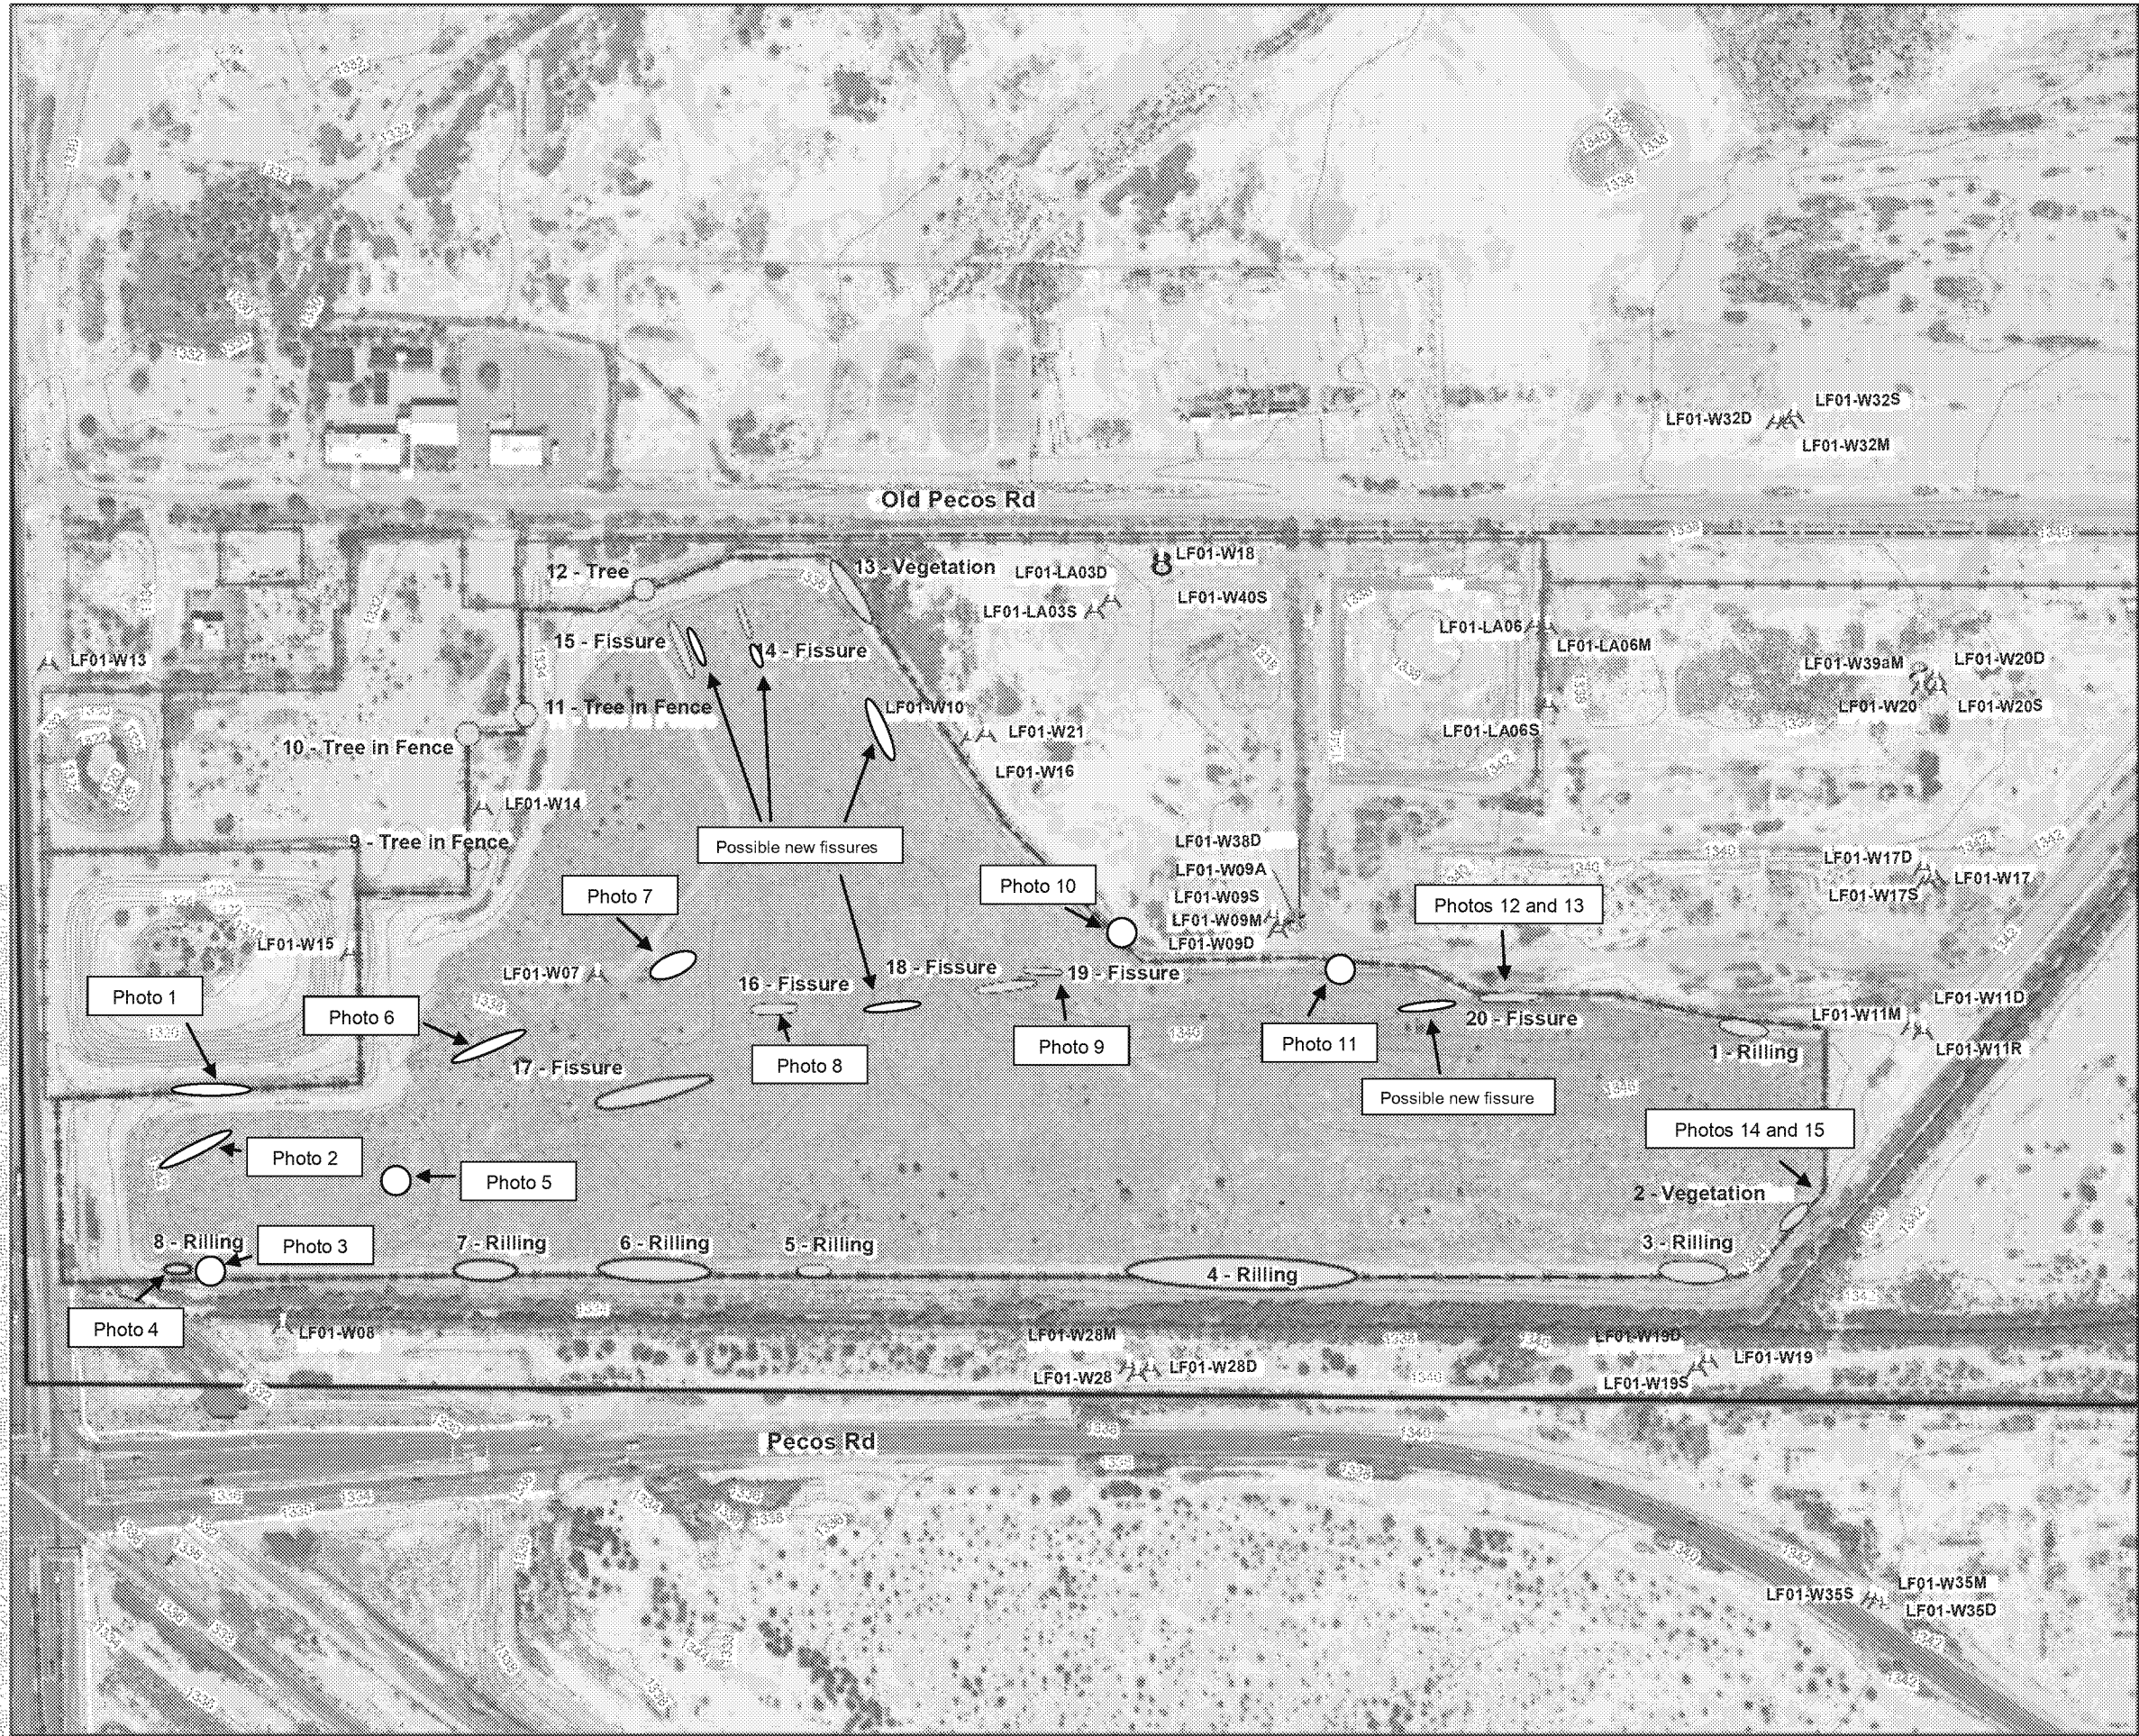
**ATTACHMENT 1
LANDFILL FEATURES**

In general, there appeared to be more fissures in the cap than during the 2017 inspection, including several apparent new fissures or extensions of previously identified fissures (see Attachment 1). Much of the fissuring appeared to be minor at this time. Some of the previous repairs were showing signs of failure (e.g., renewed fissuring on the berm along the south side of the treatment lagoon and along the northern interceptor trench). Animal burrowing continues to be an issue, but was similar in extent to the burrows identified in previous inspections. Vegetation on the cap appeared more significant than in recent years.

Amec's field crew placed stakes and flags at each of the significant features (defined as those features, such as fissures, burrows, and erosion, that appeared to exceed 6-inches in depth) to mark the locations for possible repairs.

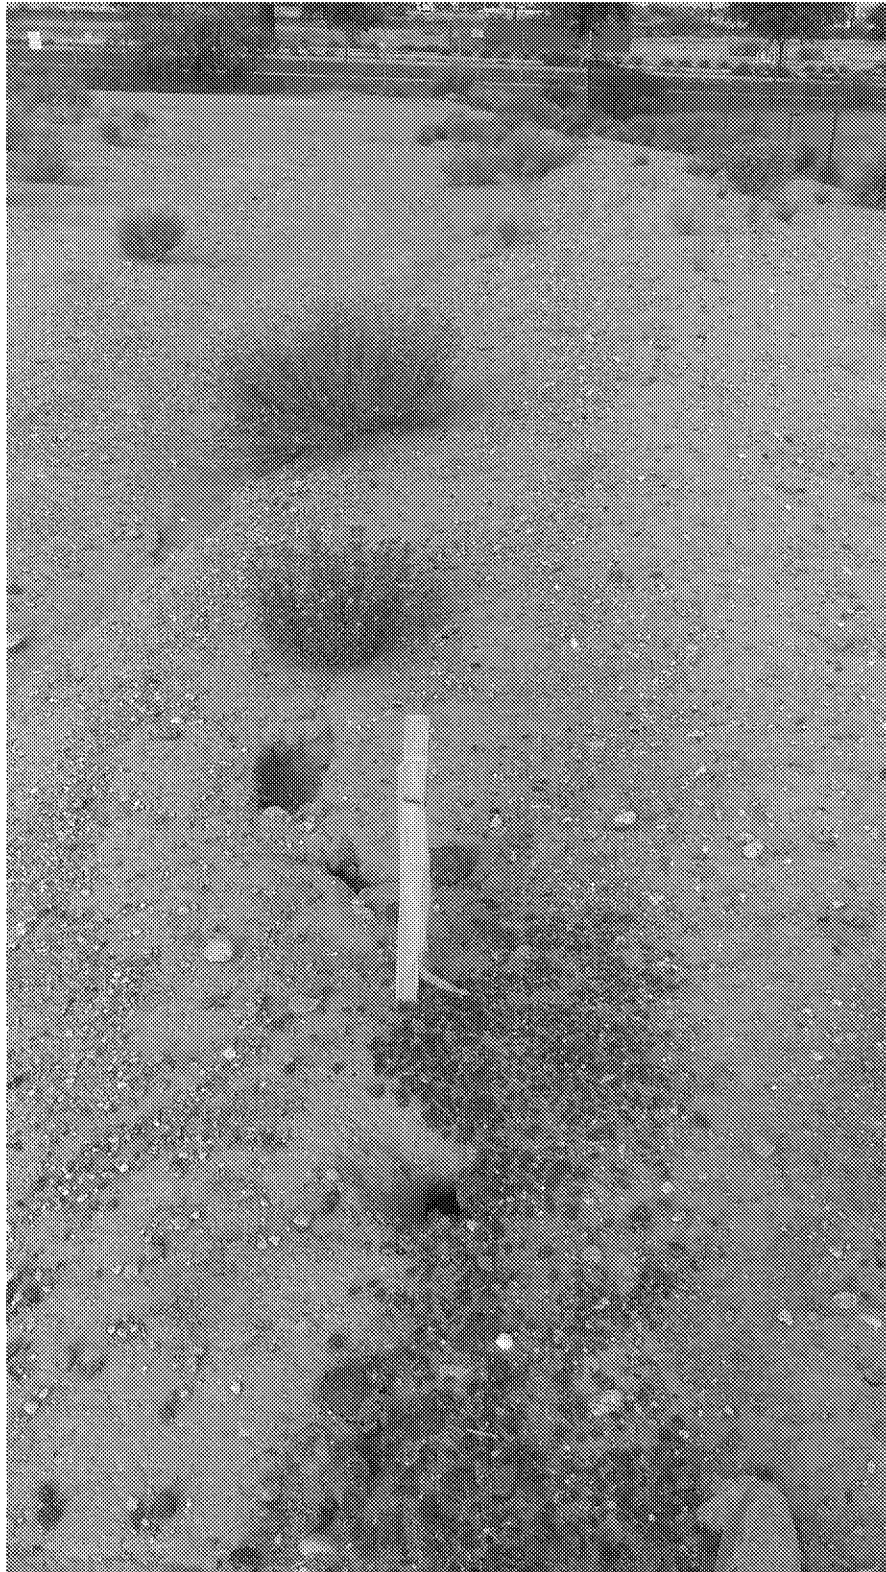
- Photo 1. Fissuring on previously repaired berm along the south side of the treatment lagoon at the west end of the landfill.
- Photo 2. Marking the location of an apparent new fissure near the west end of the landfill cover.

Photo 1. Fissuring on previously repaired berm along the south side of the treatment lagoon at the west end of the landfill.

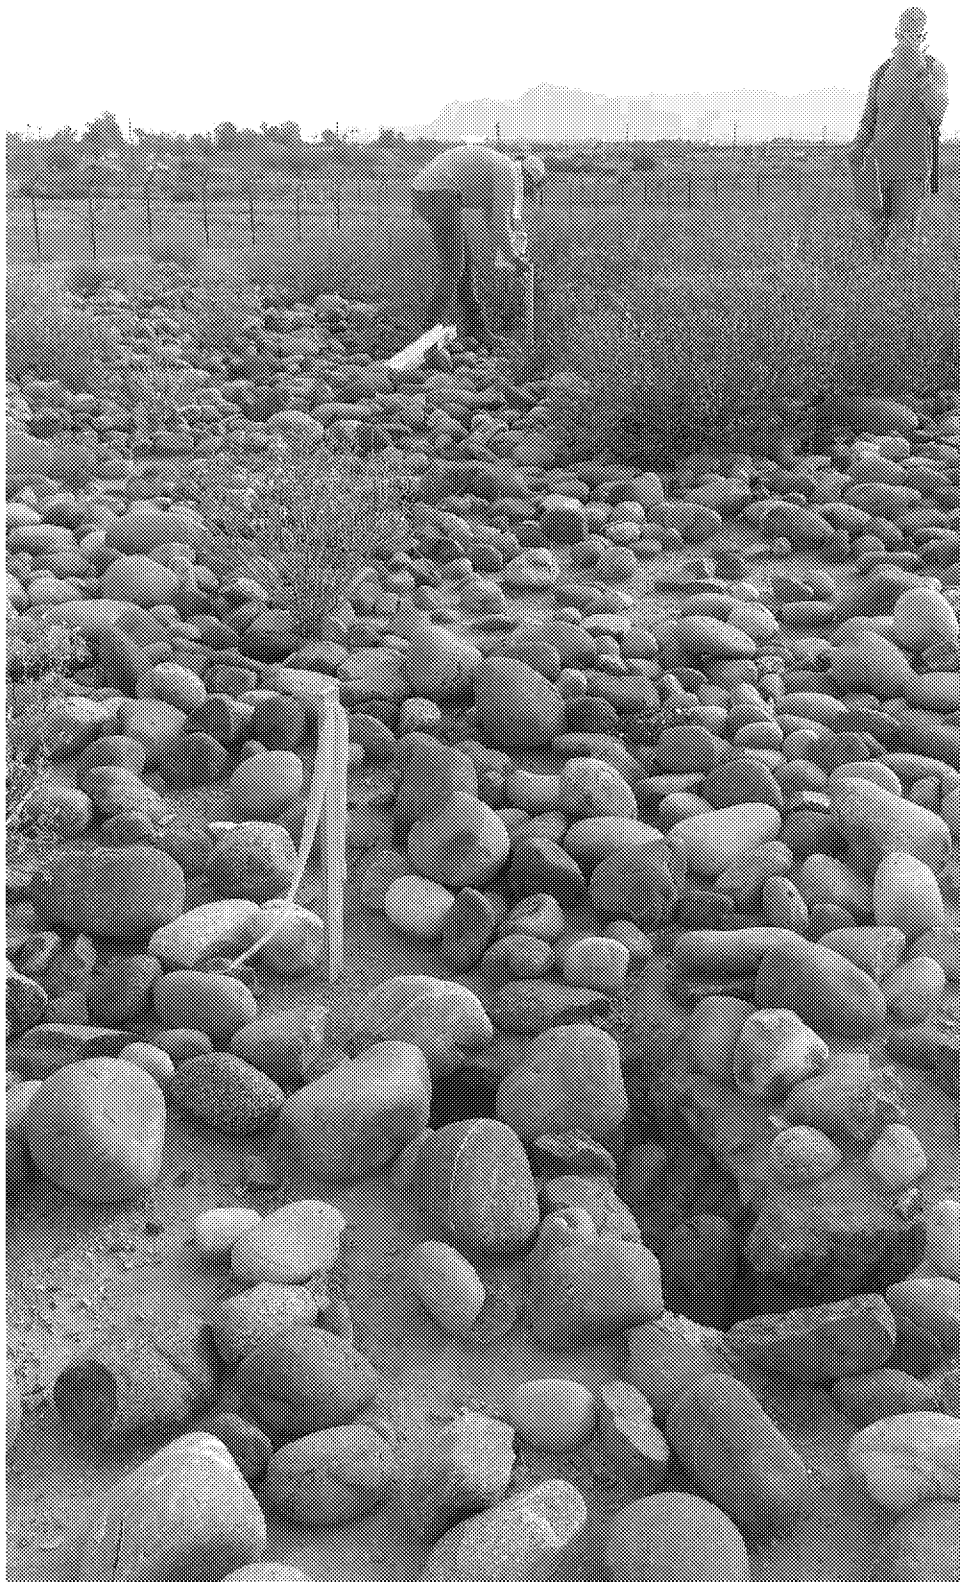
Photo 2. Marking a new fissure in the landfill cover.

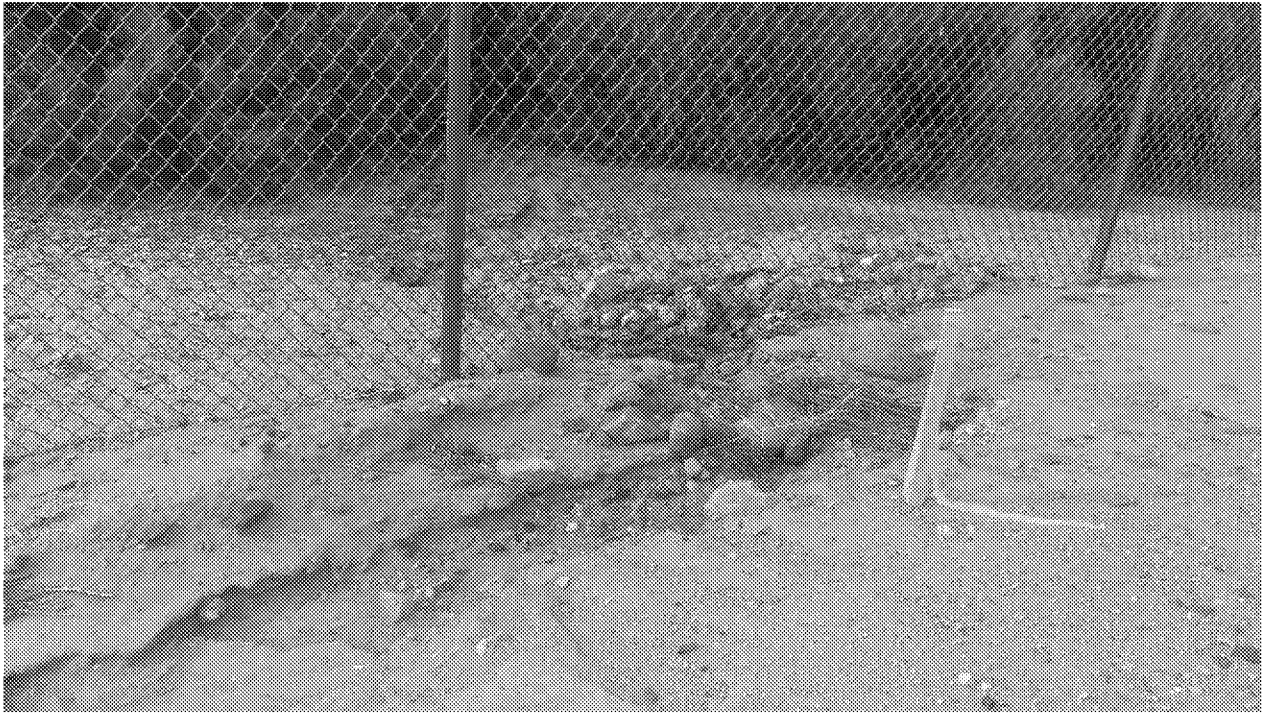
- Photo 3. Erosion beneath south boundary fence near the west end of the landfill.
- Photo 4. Minor erosion near the southwest landfill boundary.
- Photo 5. Possible animal burrow or erosional feature near the southwest end of the landfill.

Photo 3. Erosion beneath south boundary fence near the west end of the landfill.

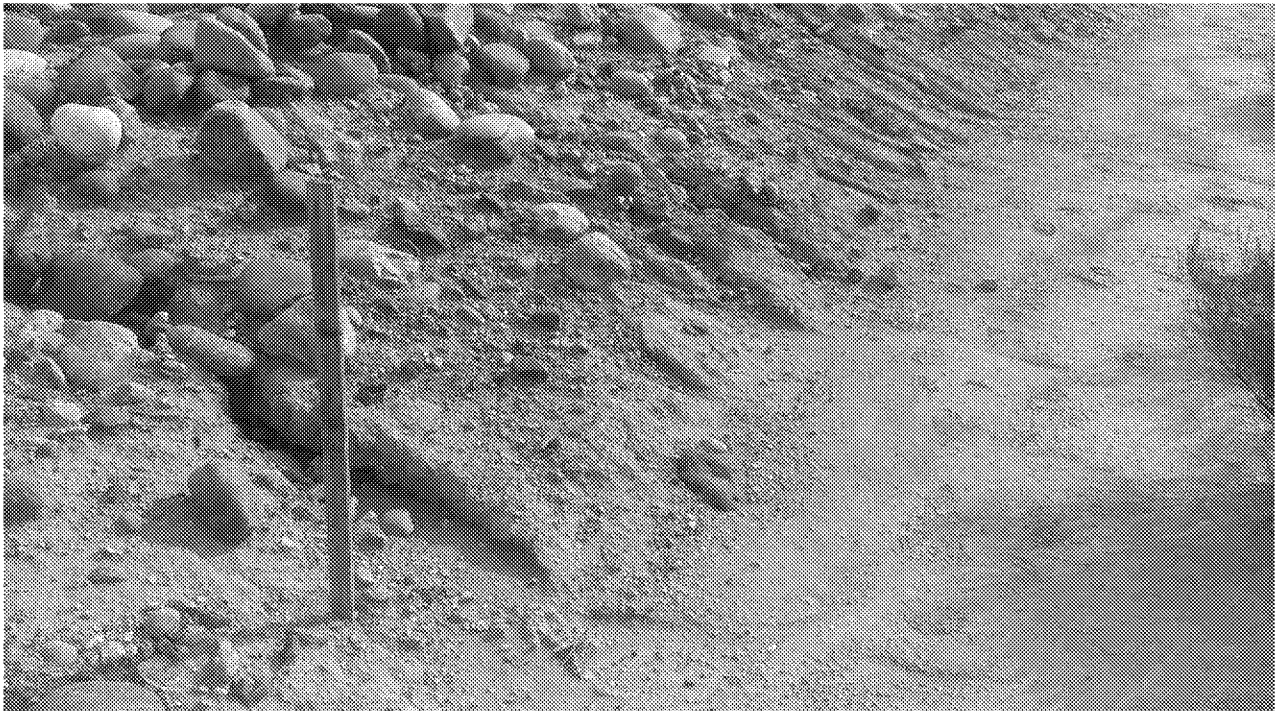
Photo 4. Minor erosion near the southwest end of the landfill.

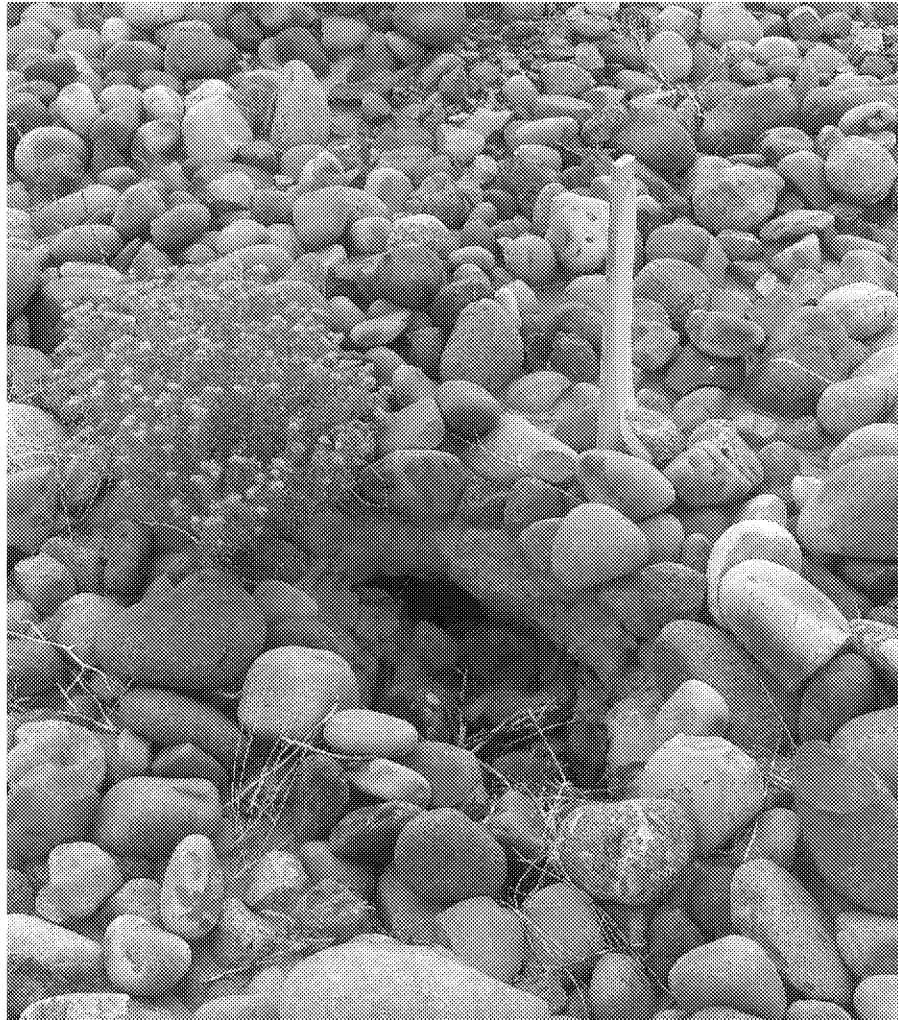
Photo 5. Possible animal burrow or erosional feature near the southwest end of the landfill.

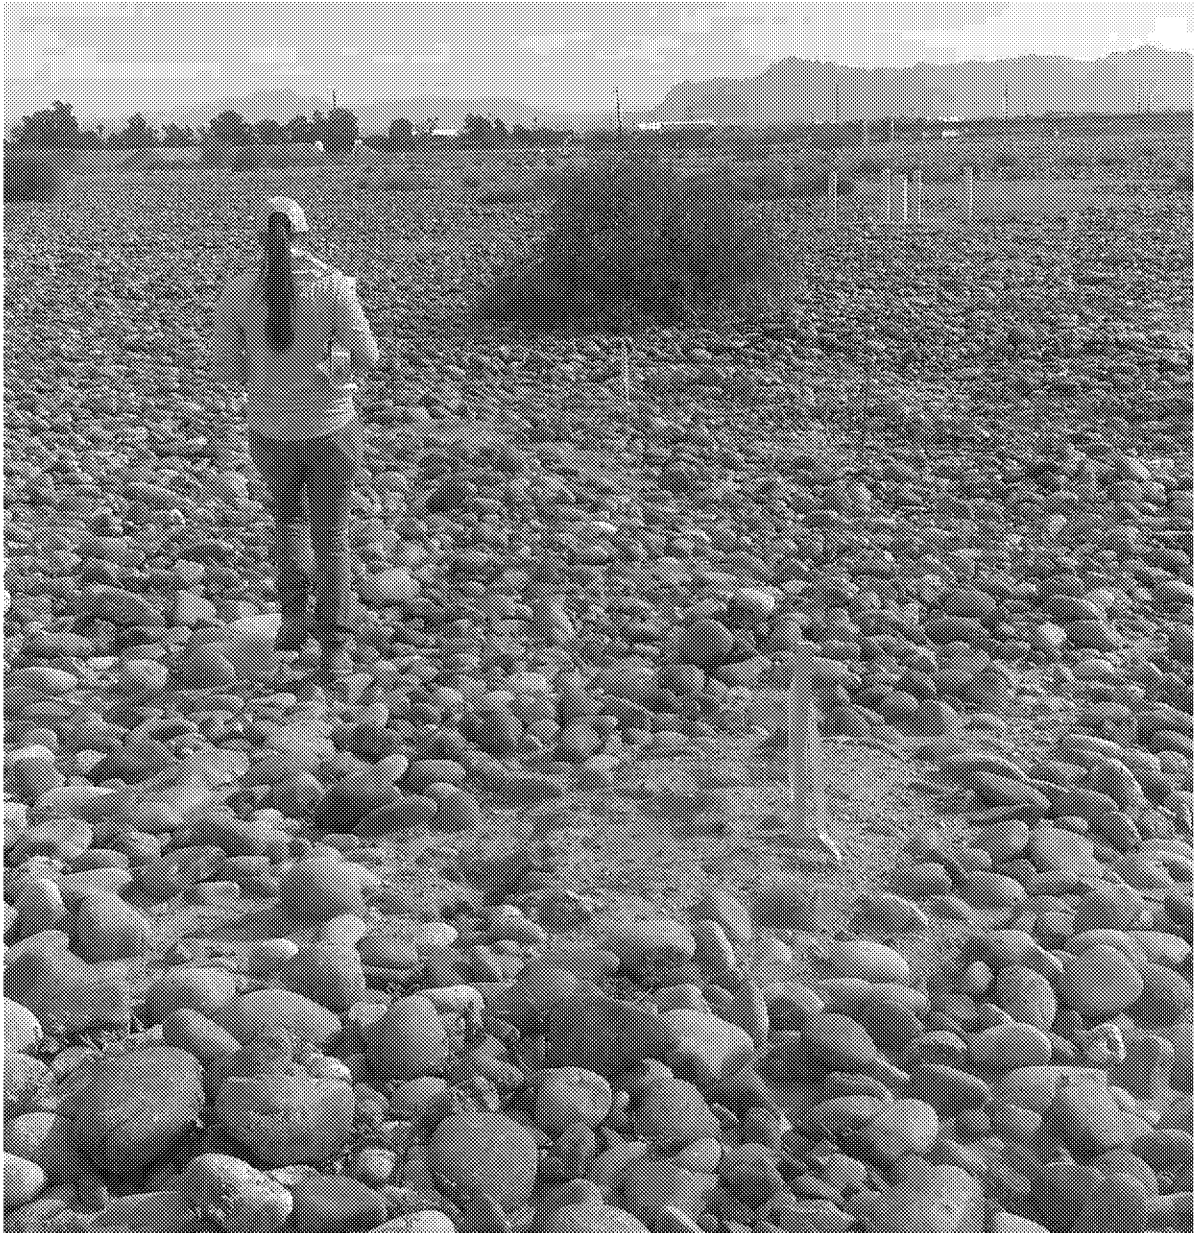
- Photo 6. Fissures on top of landfill cap, center-west area of cap, southwest of well LF01-W07. This fissure appears to be a new feature.
- Photo 7. Fissure on the east edge of the well MW-7 access pad. This may be continuous from the fissure shown in Photo 6

Photo 6. Fissures on top of landfill cap, center-west area of cap. View toward well MW-07.

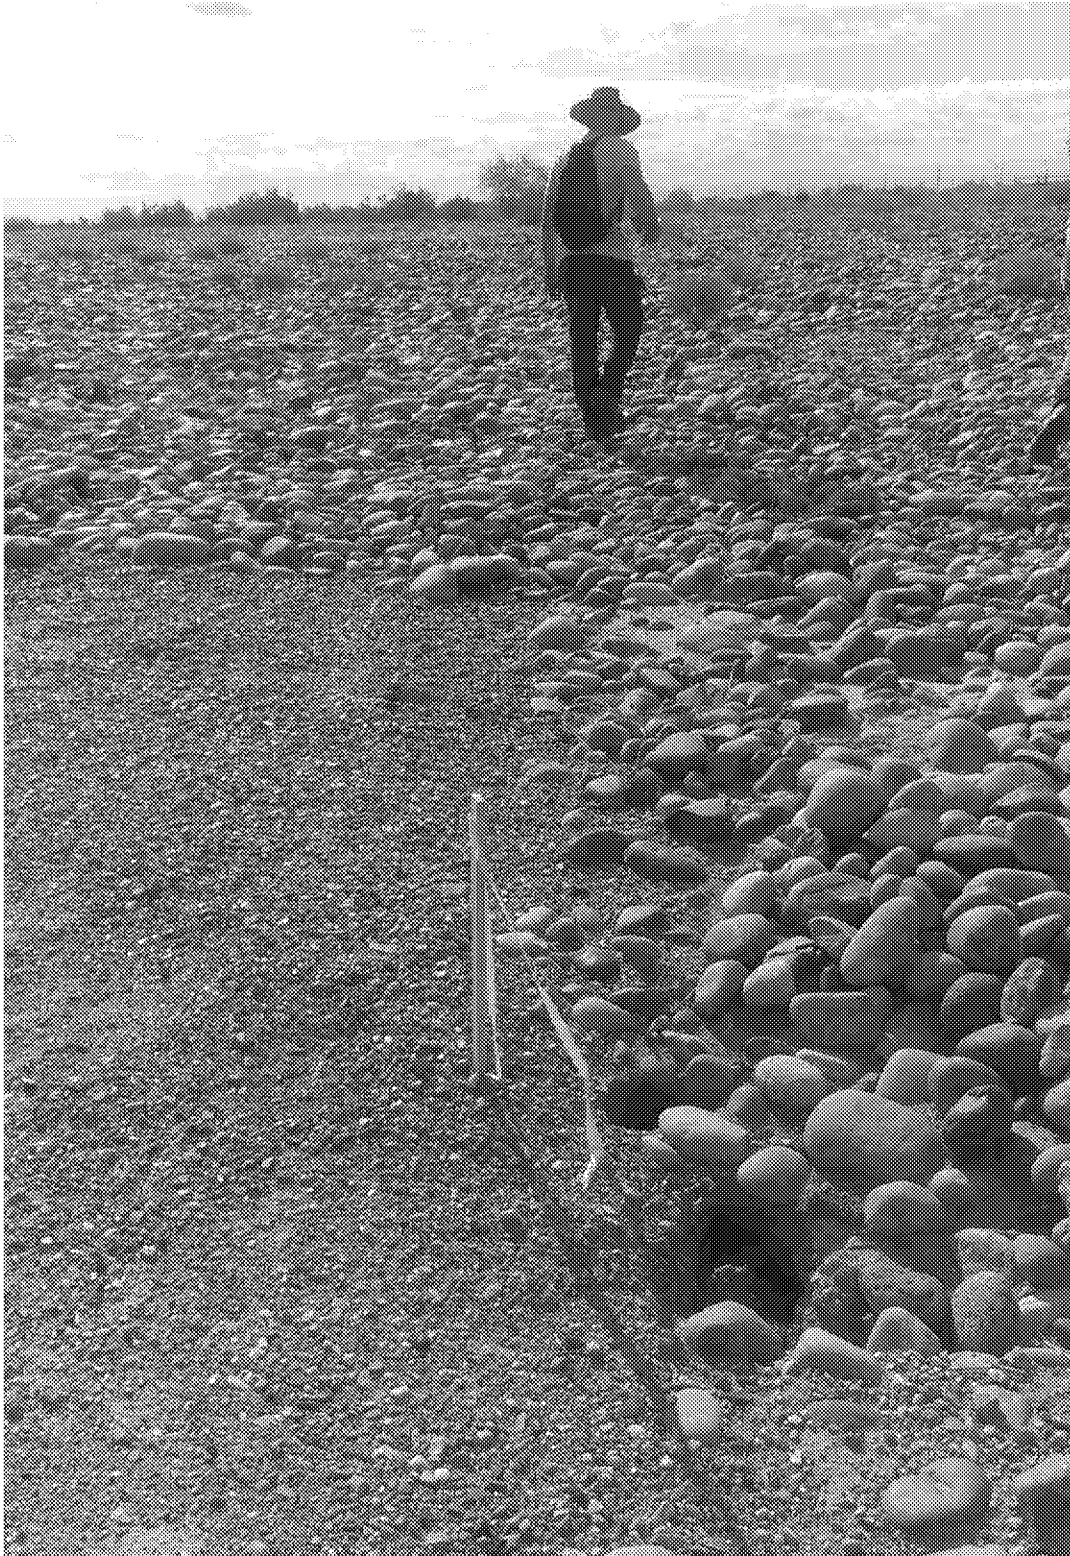
Photo 7. Fissure on the east edge of the well MW-7 access pad.

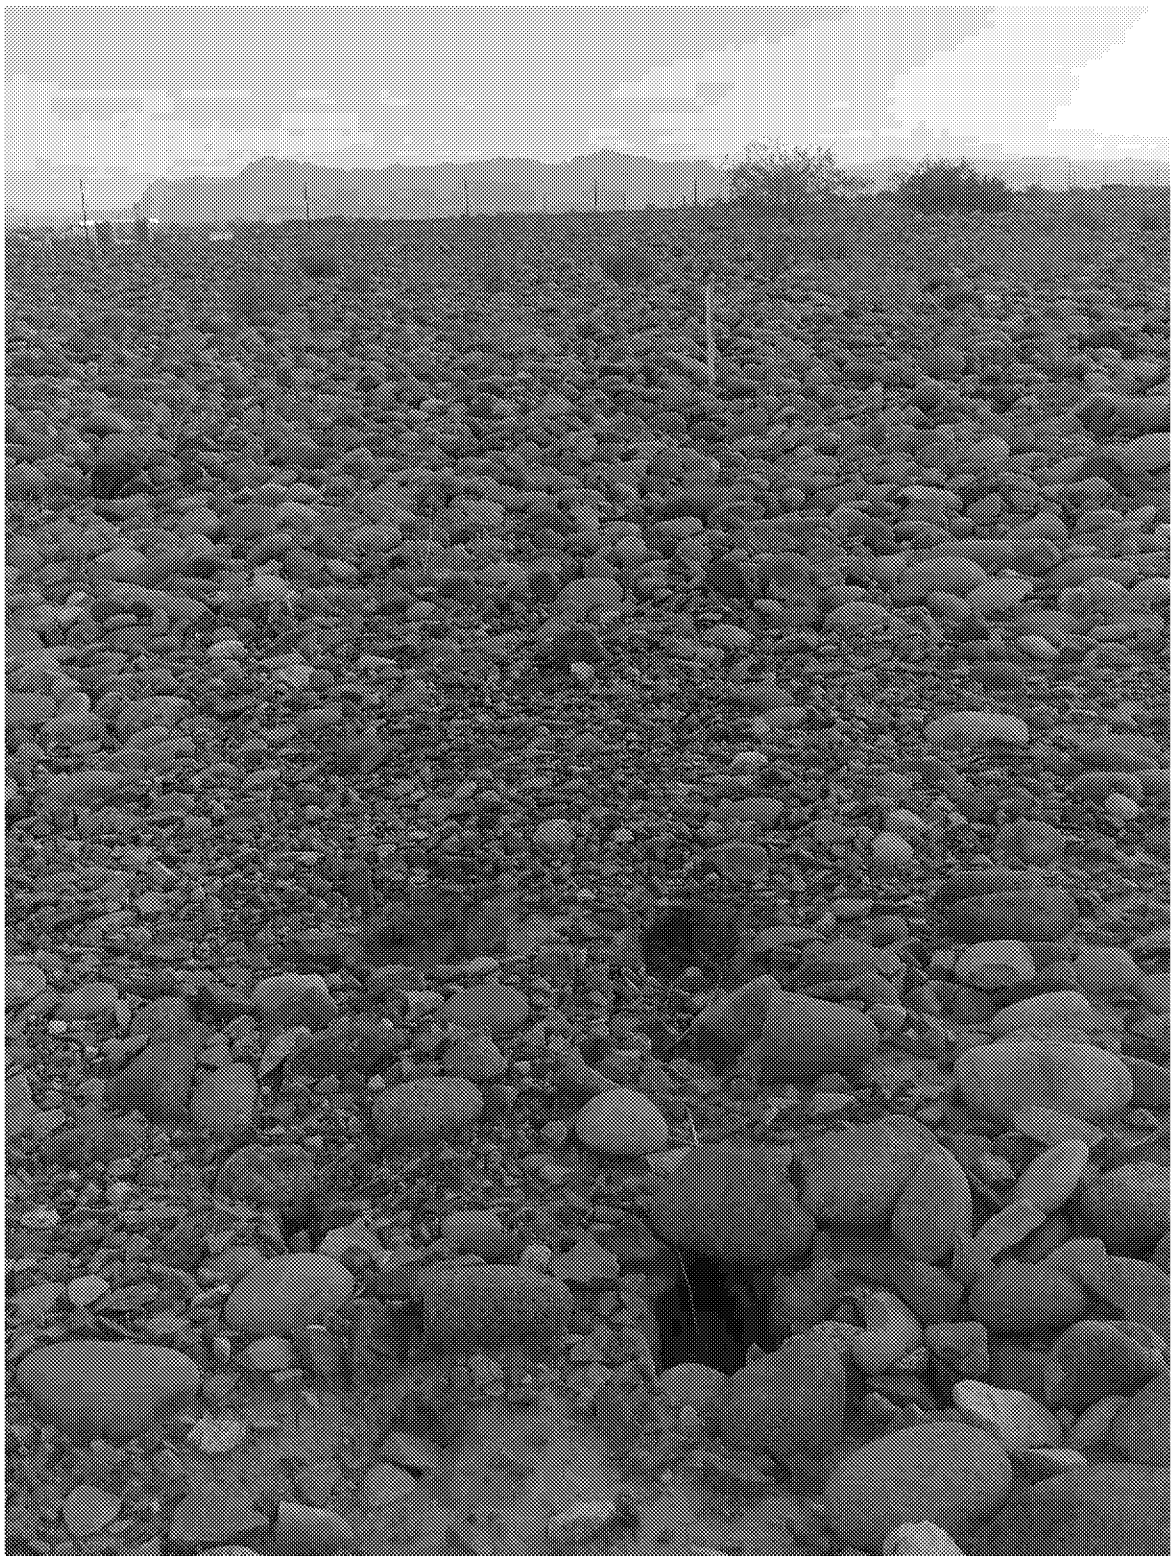
- Photo 8. Fissures on top of landfill cap, center area of cap east of well MW-07
- Photo 9. Settlement area associated with fissures near the north-central part of the landfill cap.

Photo 8. Fissures on top of landfill cap, center area of cap east of well MW-07.

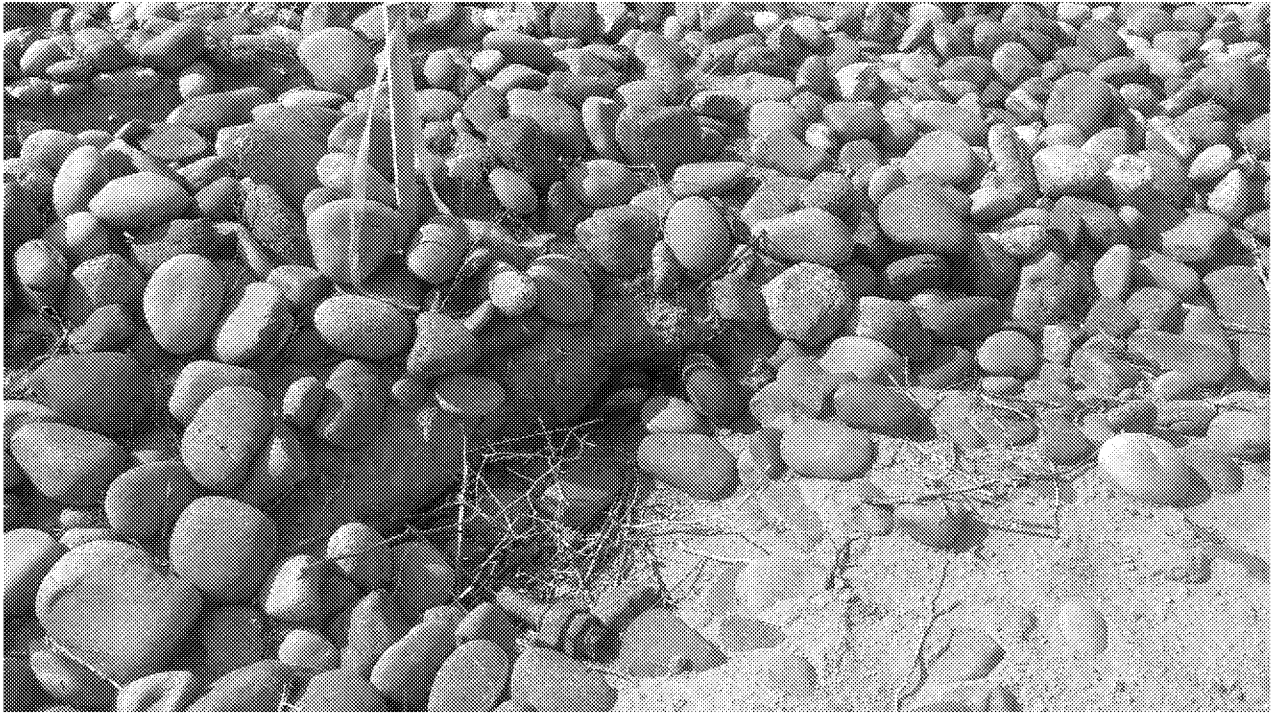
Photo 9. Settlement area on top of landfill cap near the fissure area on the north-central part of the cap.

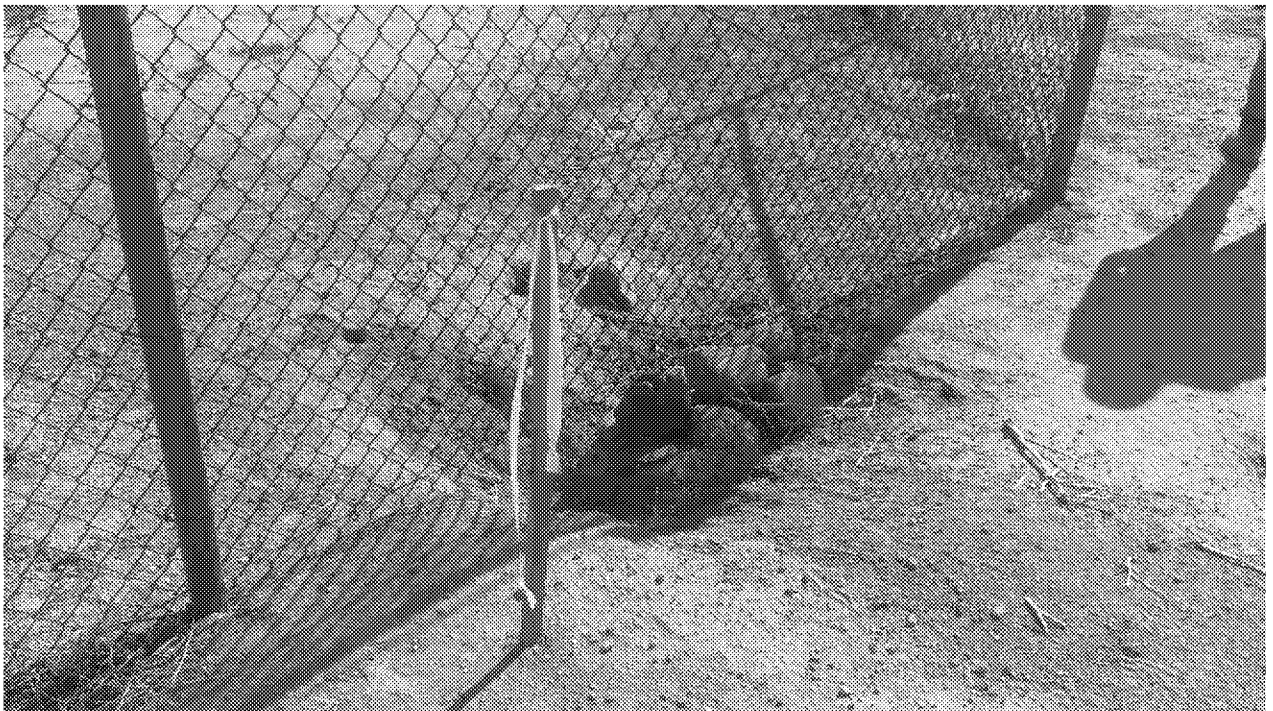
- Photo 10. Erosion under fence near previously repaired area on the north side of the landfill.
- Photo 11. Possible animal burrow at base of the slope on the north side of the landfill.
- Photos 12 and 13. Fissuring at the edge of the north interceptor trench.
- Photo 14. Erosion or animal burrowing beneath the east landfill boundary fence.
- Photo 15. Erosional rills on the east side of the landfill.

Photo 10. Erosion under fence near previously repaired area on north side of landfill.

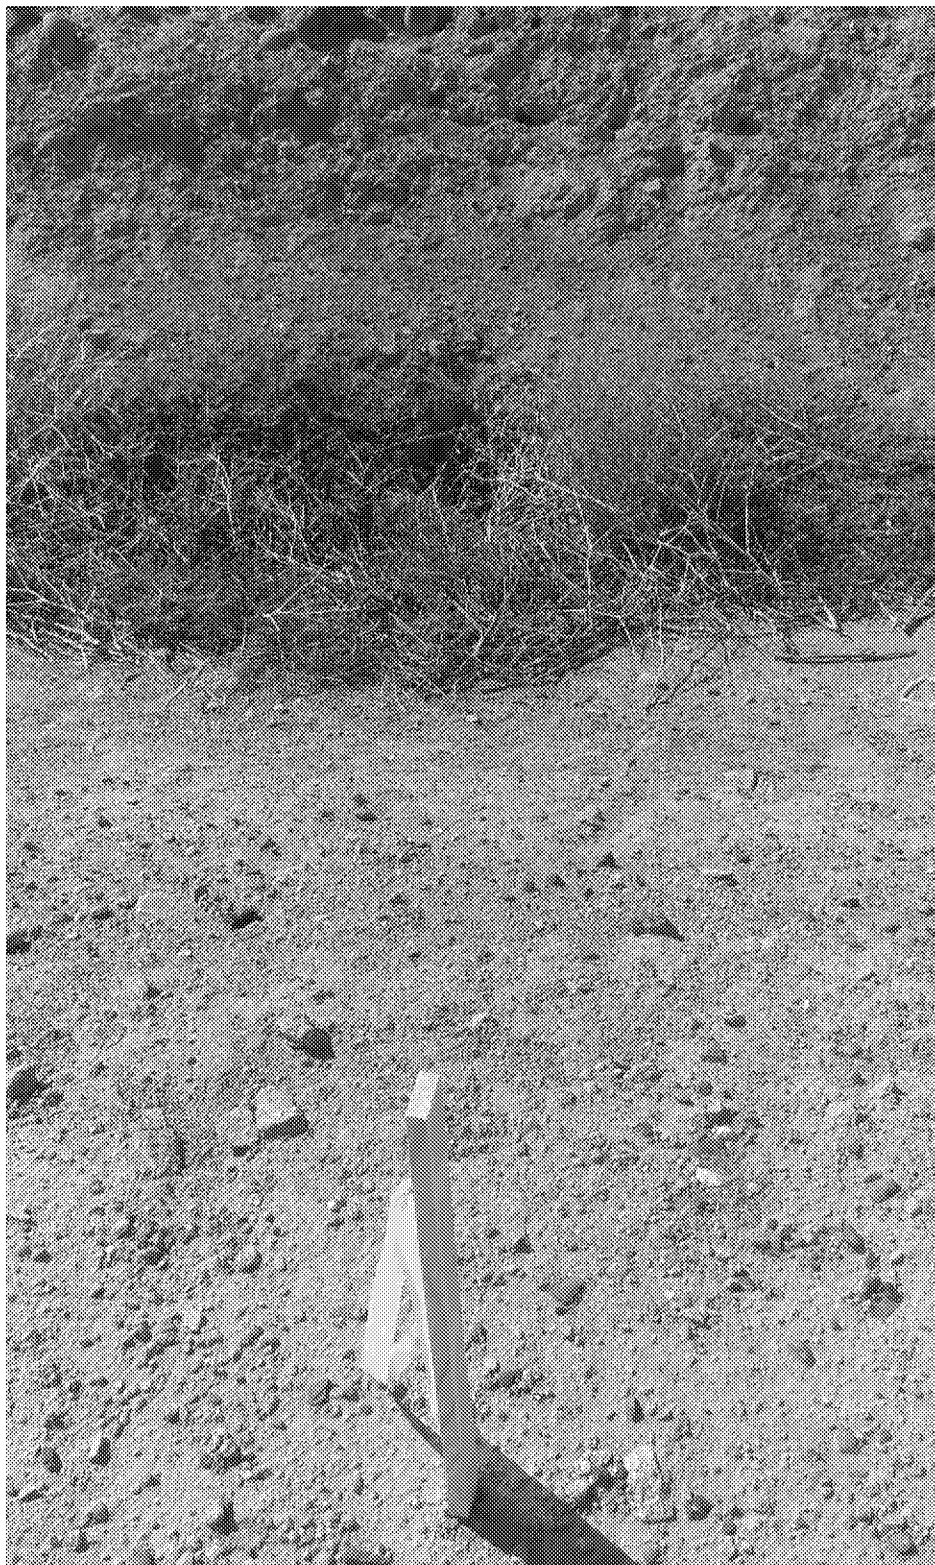
Photo 11. Possible animal burrow at base of slope on north side of landfill.

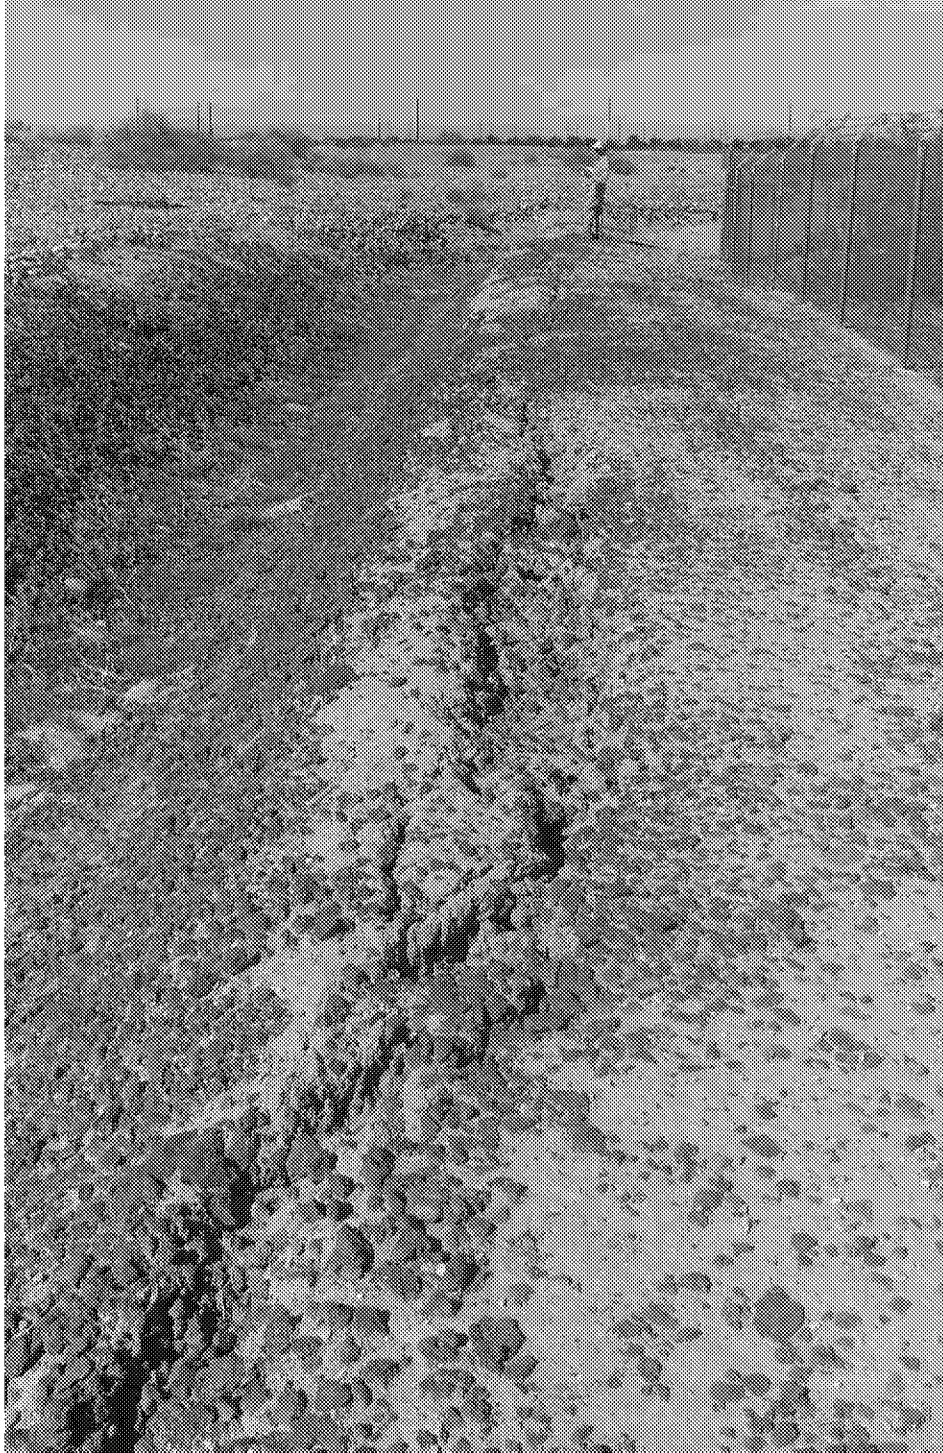
Photo 12. Fissure in previously repaired area on the north side of the northern drainage trench.

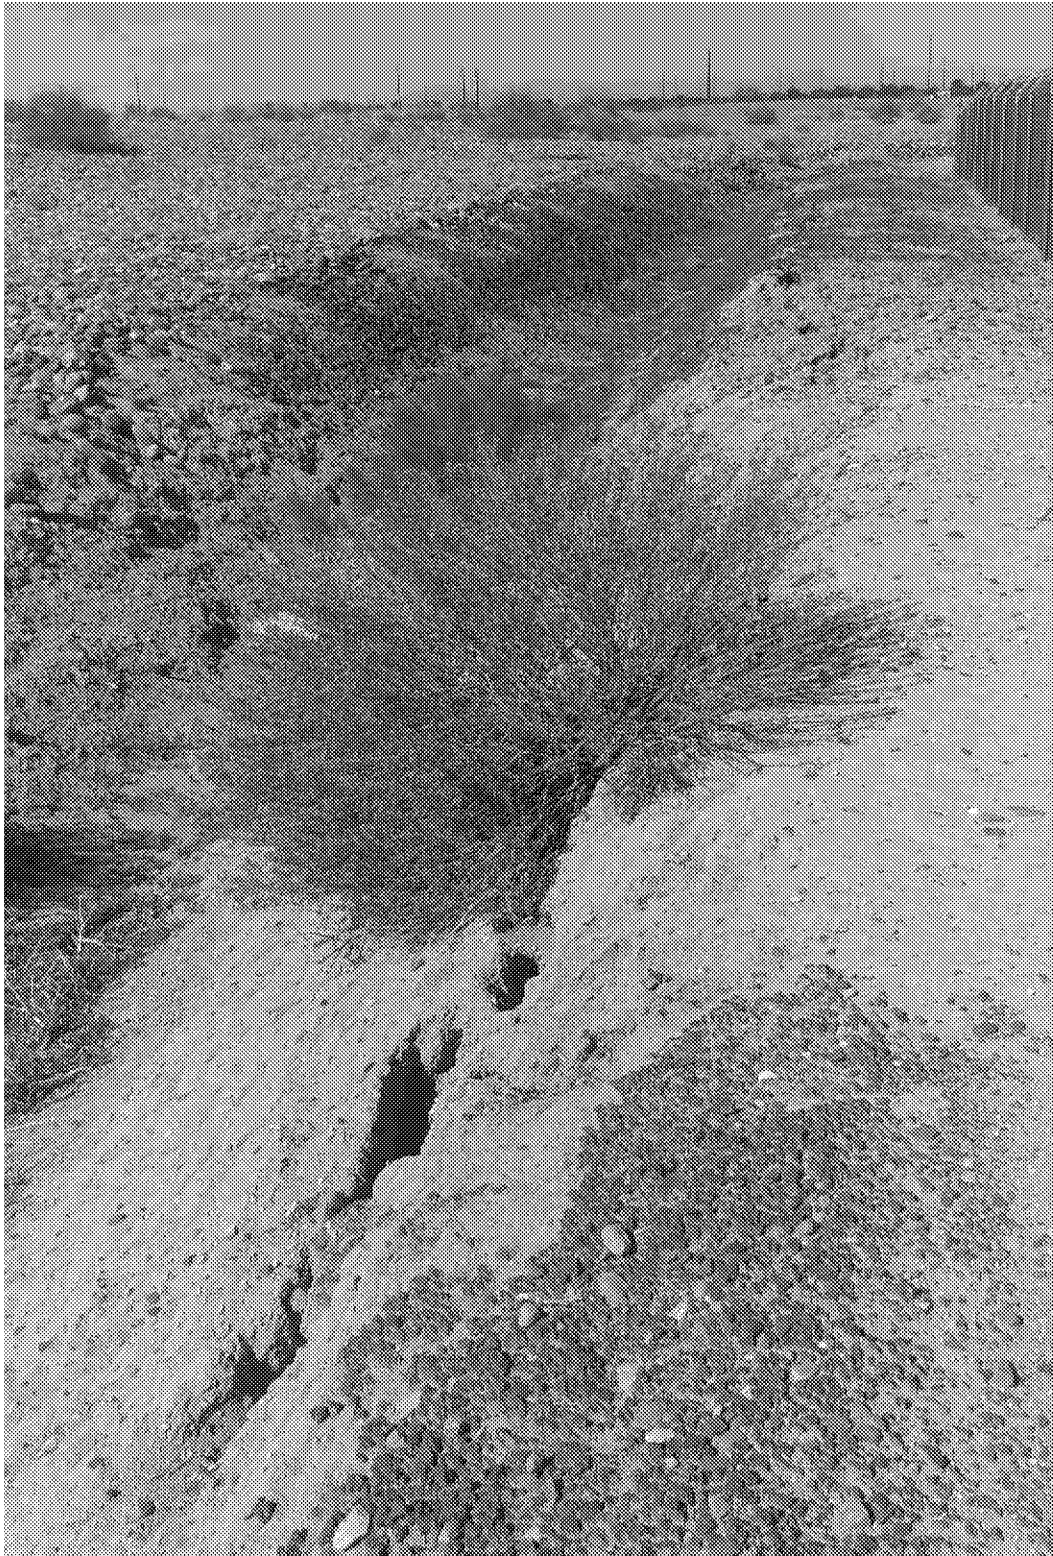
Photo 13. Eastern extent of fissure in previously repaired area on the north side of the northern drainage trench.

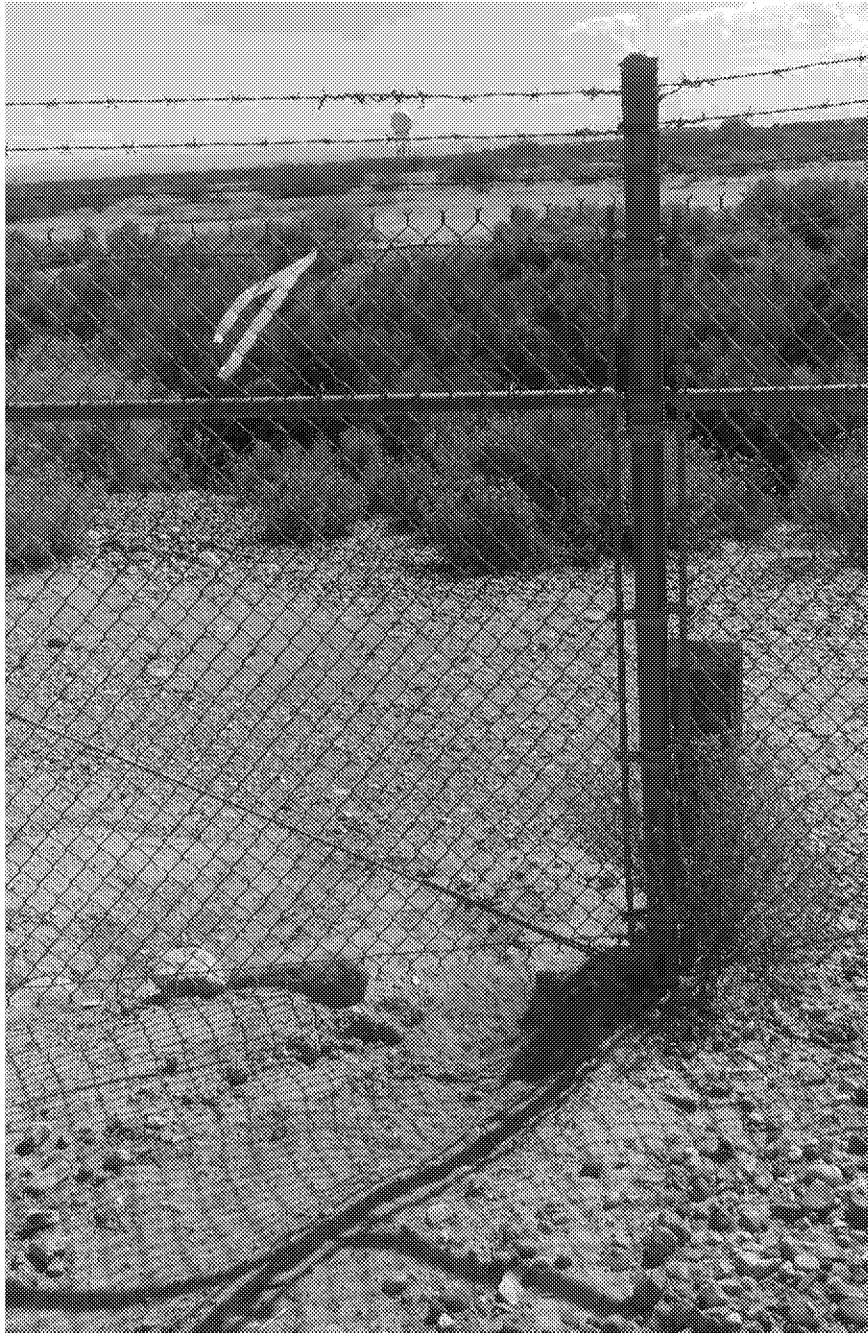
Photo 14. Erosion or animal burrowing beneath the east landfill boundary fence.
